LIMITED ASBESTOS CONTAINING MATERIALS INSPECTION

**Former Shoe Factory
185 Rowley Avenue
Vanceburg, Lewis Co., Kentucky 41179**

**REPORT DATE
April 13, 2011**

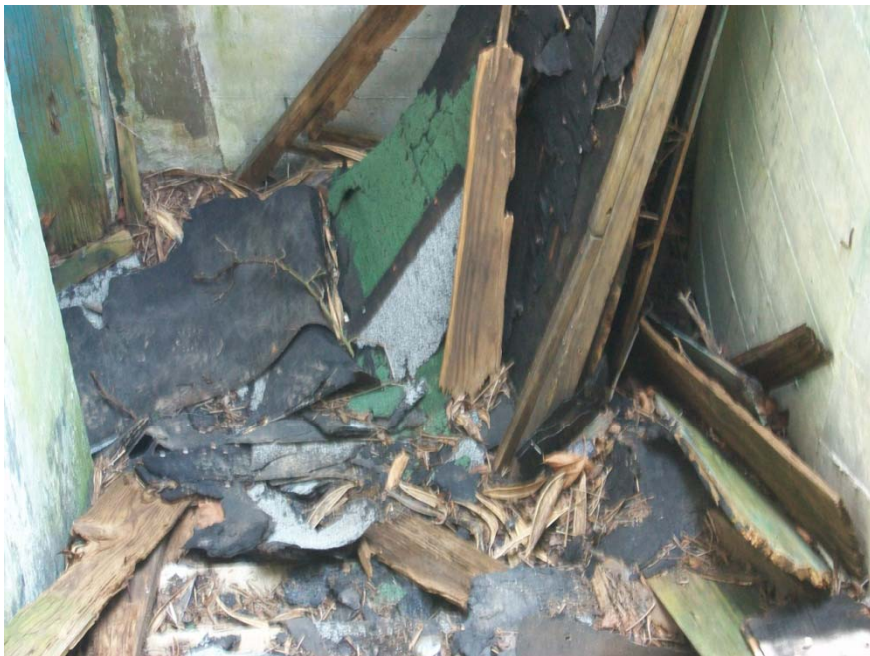
6	DESCRIPTION	View of roofing located within stairwell of wooden addition.
	DATE	March 22, 2011

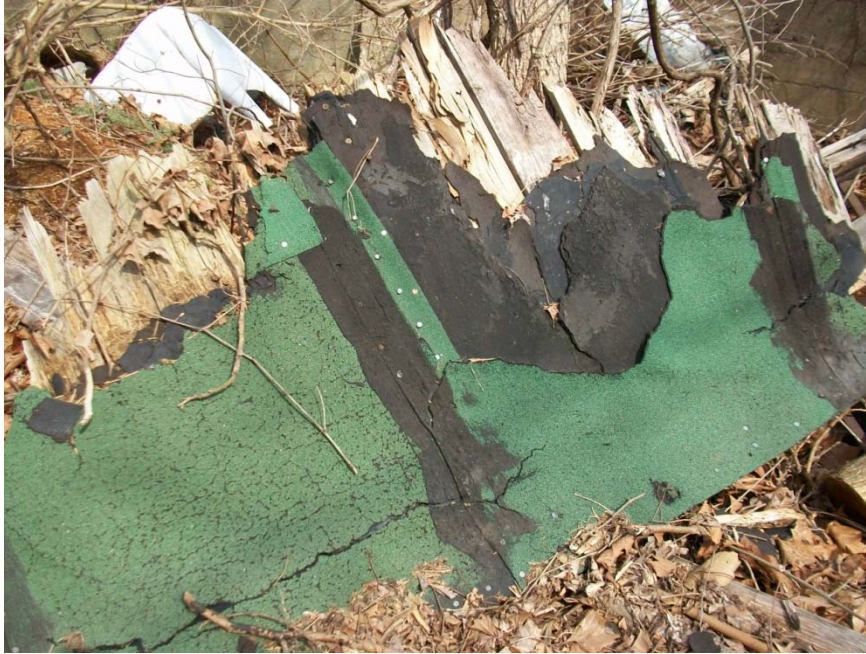
7	DESCRIPTION	View of roofing debris located on Side D of the subject property.
	DATE	March 22, 2011

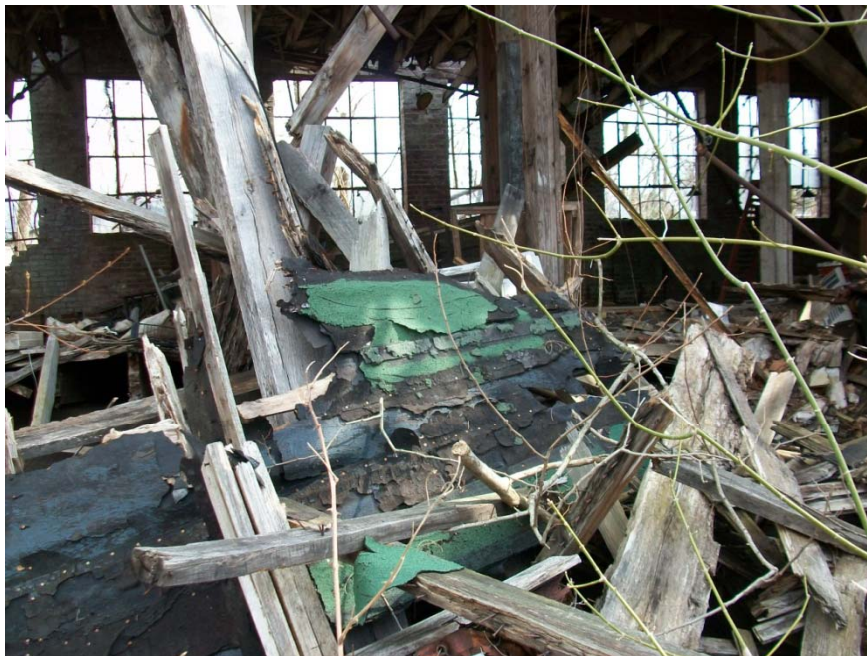
8	DESCRIPTION	View of roofing located within "Fallen Area" of subject property.
	DATE	March 22, 2011

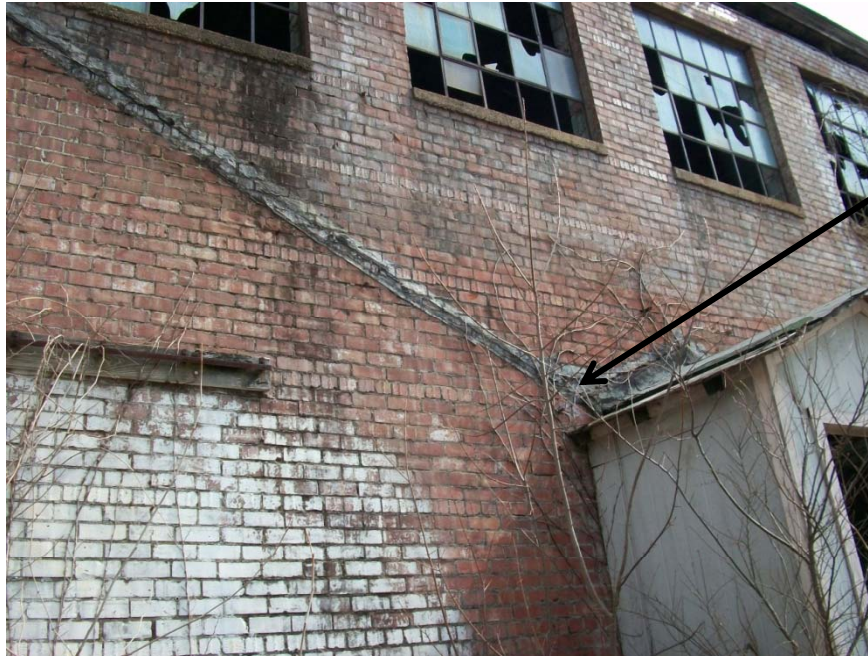
**Sample #
185-008B,C**

9	DESCRIPTION	View of wooden addition roof flashing looking east.
	DATE	March 22, 2011

3/22/2011	B	001	185-008A	Gray Flashing	Exterior - Structure Wall Above Door		NAD	NF
3/22/2011	B	001	185-008B	Gray Flashing	Exterior - Roof of Wooden Addition		5% Chrysotile	NF
3/22/2011	B	001	185-008C	Gray Flashing	Exterior - Roof of Wooden Addition		DNA	NF
3/22/2011	D	005	185-009A	Tan Corrugated-like	Interior - Basement		NAD	NF
3/22/2011	D	005	185-009B	Tan Corrugated-like	Interior - Basement		NAD	NF
3/22/2011	D	005	185-009C	Tan Corrugated-like	Interior - Basement		NAD	NF
3/22/2011	Ceiling	001	185-010A	White Chaulky-like	Interior - 2nd Floor Ceiling		NAD	F
3/22/2011	Ceiling	001	185-010B	White Chaulky-like	Interior - 2nd Floor Ceiling		NAD	F
3/22/2011	Ceiling	001	185-010C	White Chaulky-like	Interior - 2nd Floor Ceiling		NAD	F
3/22/2011	D	001	185-011A	Black Glue	Interior - Around Entire Window		NAD	NF
3/22/2011	D	001	185-011B	Black Glue	Interior - Around Entire Window		NAD	NF
3/22/2011	D	001	185-011C	Black Glue	Interior - Around Entire Window		NAD	NF

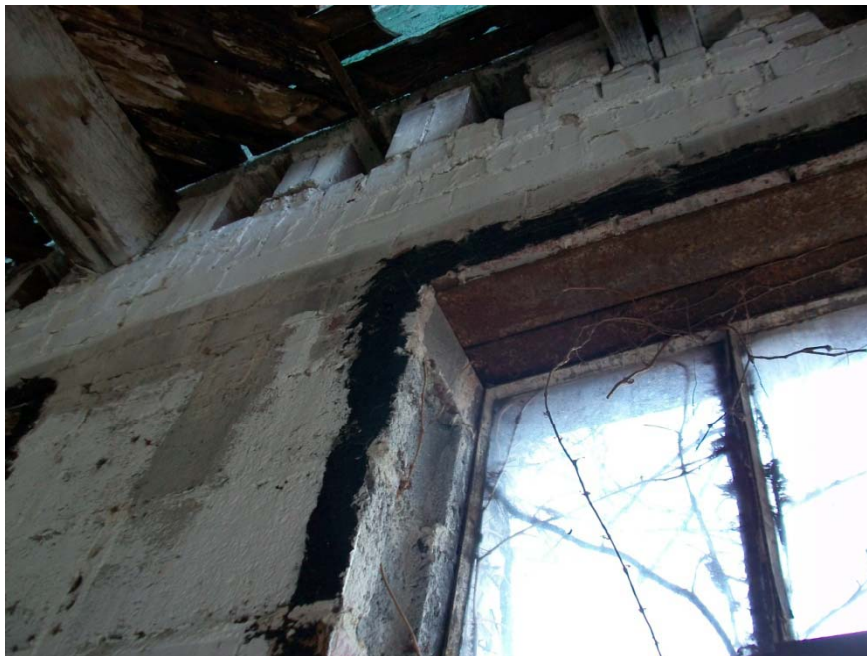
* A small amount of windows (~25%) have glazing still intact. Glazing may be present on interior floors and surrounding areas. 9,800 linear feet is the amount if all intact windows had all the glazing present.

10	DESCRIPTION	Interior view of window glazing located within “Area 001” of subject property.
	DATE	March 22, 2011

3/22/2011	D	001	185-012A	Gray Window Glazing	Interior - Window Pane		2% Chrysotile	NF
3/22/2011	D	001	185-012B	Gray Window Glazing	Interior - Window Pane		DNA	NF
